Advantage of Polyester braid hose

Corrosion Resistant Braided Water Connectors

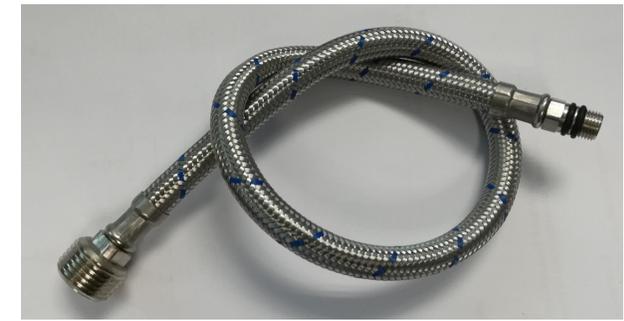
Standard AISI 304 stainless steel

Normal Passed 100 Bar (1450PSI) burst pressure testing

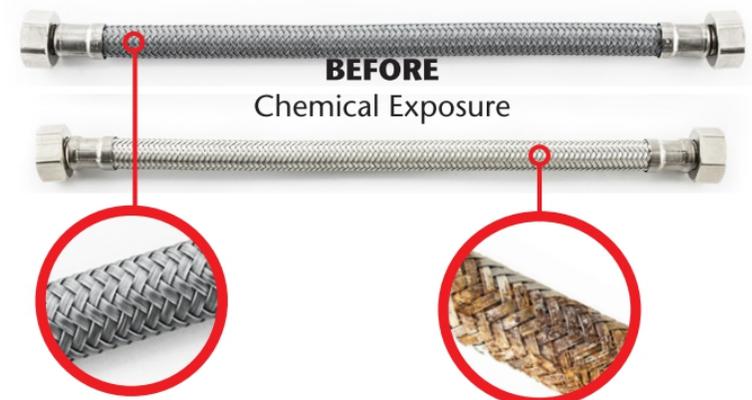
Single wire grey polymer
AFTER
Chemical Exposure

Standard AISI 304 Stainless Steel
AFTER
Chemical Exposure

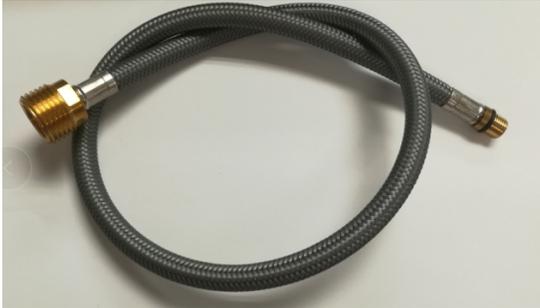
1. Grey Polyester monofilament of 0.30 mm.: withstands 125 bar burst pressure.

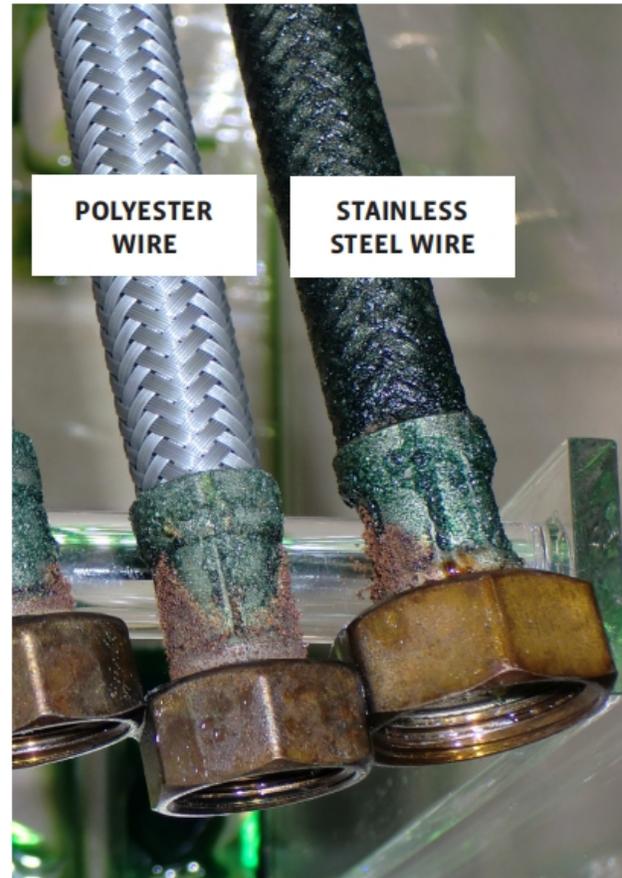
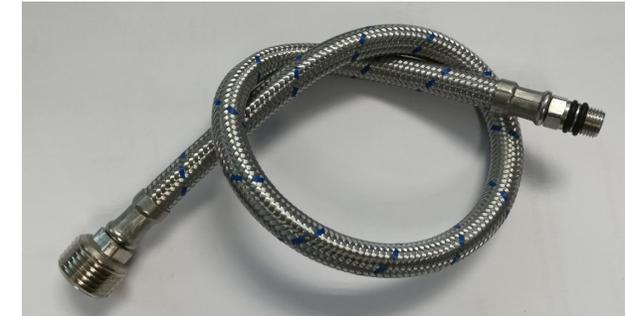
2. Standard TUCAI AISI 304 Stainless Steel braided hose: withstands 135 bar burst pressure. Braid bursts.

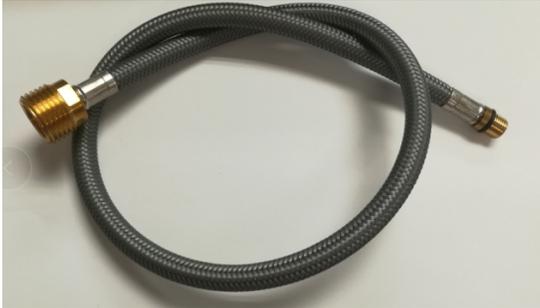
1. Grey Polyester monofilament of 0.30 mm.: withstands 130 bar burst pressure.

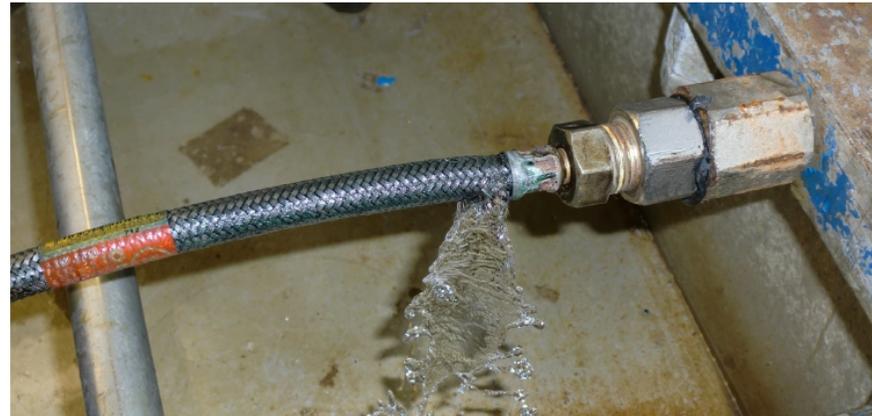
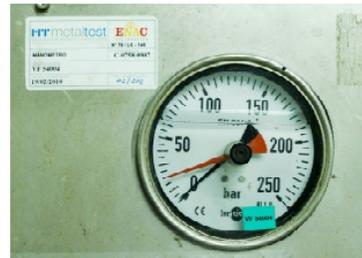
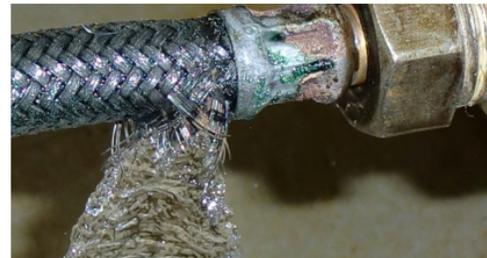
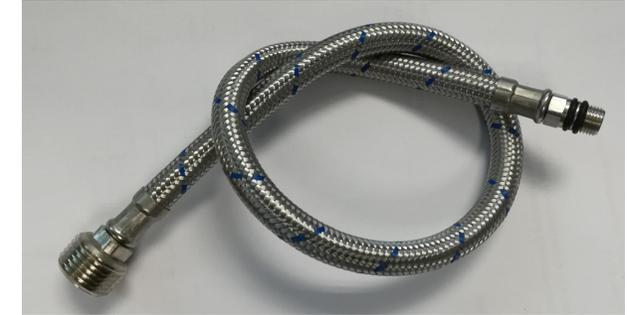
STAINLESS STEEL BRAIDED HOSE BURST PICTURE
RESULT: 20 BAR (TEST FAILS)

2. Standard TUCAI AISI 304 Stainless Steel braided hose: withstands **20 bar** burst pressure. Braid bursts close to sleeve. **TEST FAILS**

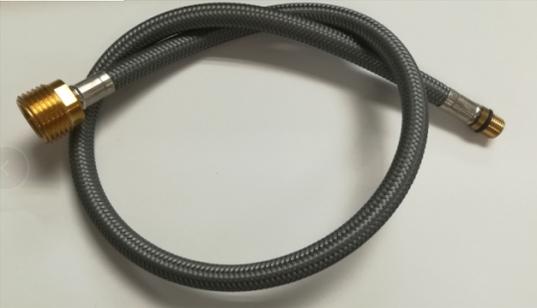
1. Grey Polyester monofilament of 0.30 mm.: withstands 130 bar burst pressure. Properties and performance values remain unchanged.

The visual aspect of the Polyester braided hose is very good. The different tests show that the Polyester braid has performed better than the rest of materials. Performance of this particular hose remains unchanged with respect to the first testing day.

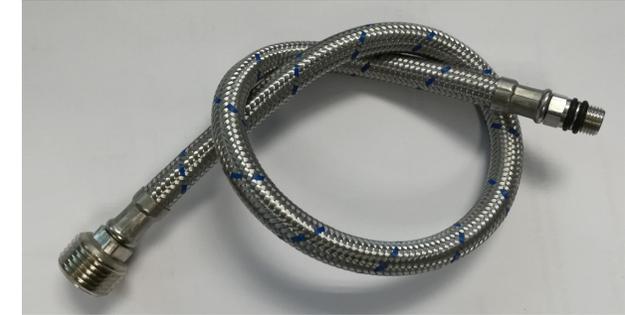
2. Standard TUCAI AISI 304 Stainless Steel braided hose: withstands **3 bar** burst pressure. Braid bursts due to a severe deterioration. **TEST FAILS**

The test results show that a Stainless Steel braided hose exposed to a continuous corrosive agent like hydrochloric acid during one month presents signs of extreme deterioration. Picture 1 shows the magnified detail of the deteriorated braid before test is run. Some broken wires (0.20 mm) can be seen.

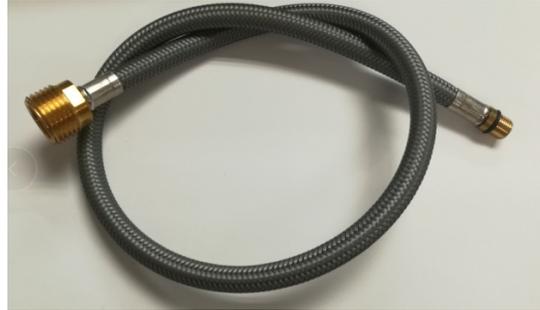
a) Arrange the samples according to length so that the clamping height H is approximately half-way between the free hose assembly ends. The distance L shall be fixed so that the free hose assembly lengths are axially oriented under load. The bending radius is defined for each nominal size in Table 10.

b) Apply a tensile force in accordance with Table 10, with the hose assembly resting against half the circumference (zone A in Figure B.4) of the test specimen.

c) Determine the ovality as the smallest outside diameter D_e of the hose assembly in the middle area (zone B in Figure B.4) of the bending loop by intermediate bending from three measured values.

d) The ovality, in percent, shall be calculated from Formula (B.1) $O = (D_a - D_e) / D_a \cdot 100$
(B.1) The ovality to be measured shall not exceed 15 %.
